Professional Home Inspection Services

ABC 123 Lane, Atlanta, GA 30033

Prepared for: **John Doe**

Prepared by: **Professional Home Inspection Services LLC**
340 Honeysuckle Terrace
Woodstock, GA 30188
404-538-8511

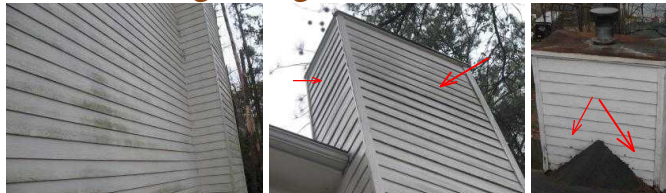
2. Type: **Composite Lap Siding** Noticed areas of siding that is starting to delaminate. This type of composite wood siding has a history of failure. There has been in the past a class action law suit against the manufactures of this siding. Recommend replacing the worse areas of siding and psi wash caulk and paint to better preserve the remaining siding that is decent condition.

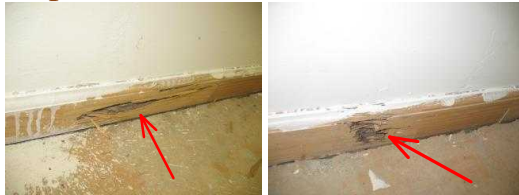
1. Structure Type: **Wood frame**
2. Foundation: **Poured Walls, Poured slab**
3. Differential Movement:
4. Beams: **Solid wood**
5. Bearing Walls: **Frame** Noticed termite damage to base trim of bearing wall in closet at back left corner of house that goes under stairs to upstairs. Recommend a termite inspection to further evaluate

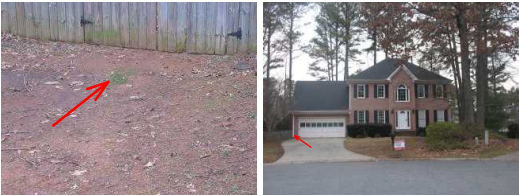
2. Grading: **Minor slope, Flat** Noticed area on the left side of the house that pooling water. It appears the majority of the water going to this area is coming from the downspout at driveway left of garage door. I would recommend adding some elbows to downspout to kick the water over more onto the driveway to allow water to drain down driveway to street.

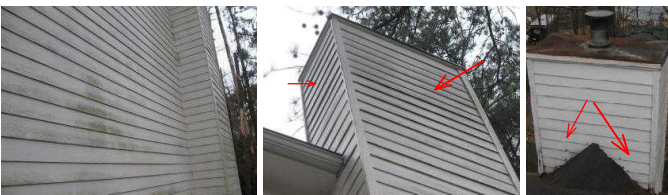
5. Side(s), Back Exterior Surface Type: **Composite Lap Siding** Noticed areas of siding that is starting to delaminate. This type of composite wood siding has a history of failure. There has been in the past a class action law suit against the manufactures of this siding. Recommend replacing the worse areas of siding and psi wash caulk and paint to better preserve the remaining siding that is decent condition.

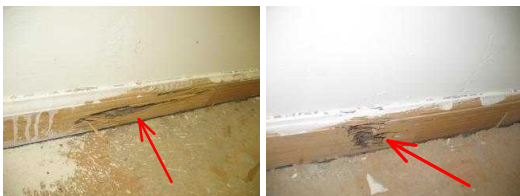
12. Bearing Walls: **Frame** Noticed termite damage to base trim of bearing wall in closet at back left corner of house that goes under stairs to upstairs. Recommend a termite inspection to further evaluate
